Date of survey.....	XX/XX/XX	Name of vessel.....	XXXXXX
Date of report.....	XX/XX/XX	Manufacturer.....	Cape Dory
Official number...	XXXXXXXX	Model.....	CDT 28 Cruiser
Hull identification number (HIN).....	XXXXXXXXXX	LOA.....	27'11"
Fair market value	\$0.00	Displacement.....	7,500#
Replacement cost...	\$0.00	Beam.....	9'11"
		Draft.....	2'11"
		Year of Manufacture	1988

Submitted without prejudice,
McGoldrick Marine Surveying, LLC
By Kevin J. McGoldrick, President

Type of survey: Condition & Valuation Survey	Date of request: XX/XX/XX
Location of Vessel: XXXXXXXXXXXXXXXXXX XXXXXXXXXXXXXXXXXX XXXXXXXXXXXXXXXXXX	Navigational limits: Underwriter Determined
Use of vessel: Pleasure	Hauled: No – vessel was docked at a slip.
Individuals present at time of survey: 1. Mr. Kevin McGoldrick – Surveyor 2. XXXXXXXXX – Owner

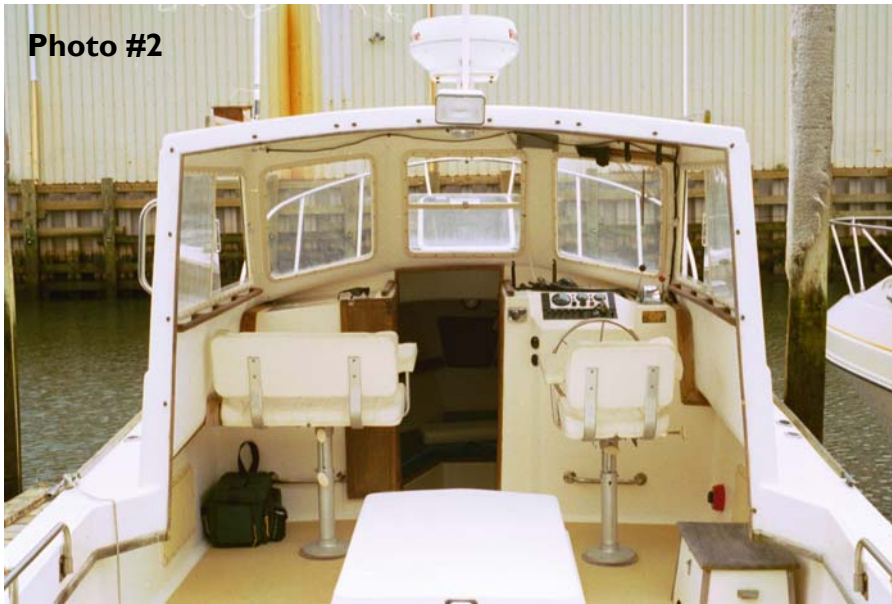
Photo #2

← Cockpit view.

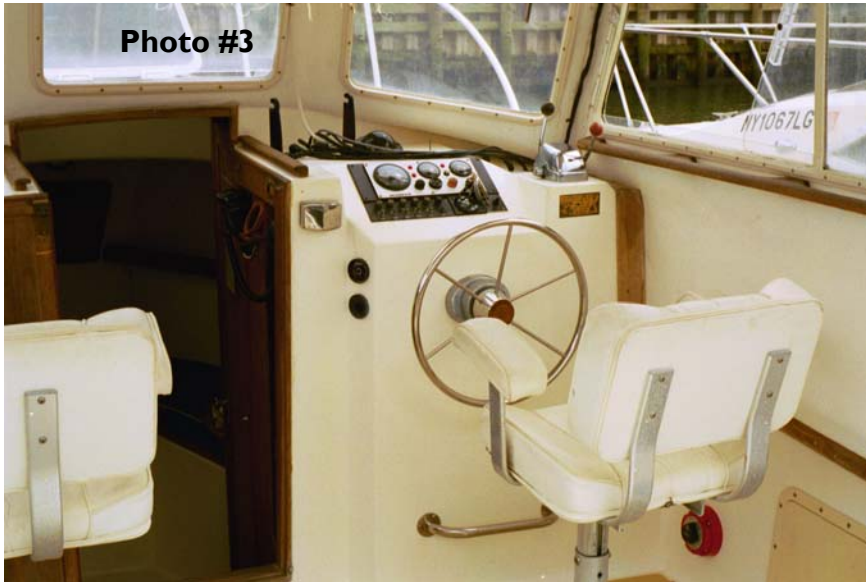
← View of helm.

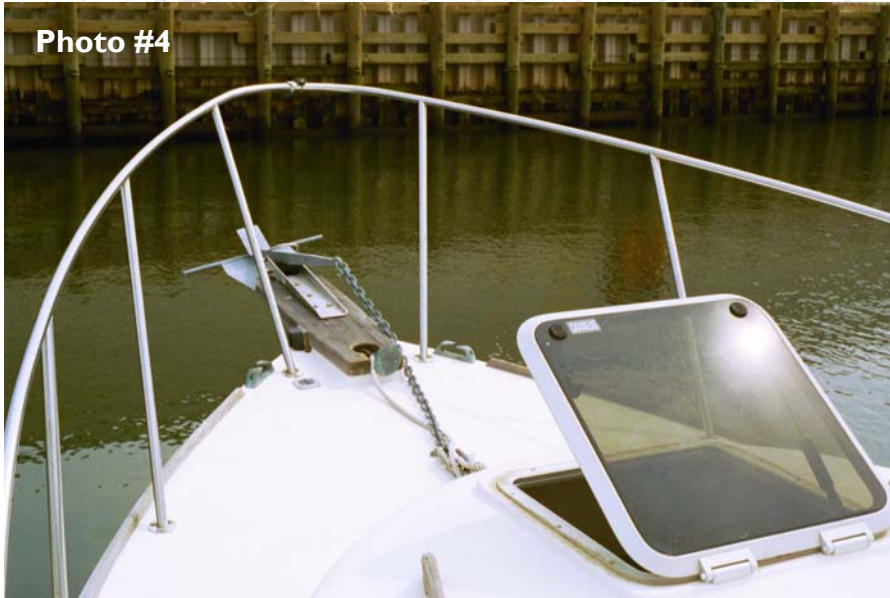
← View of foredeck/anchor pulpit.

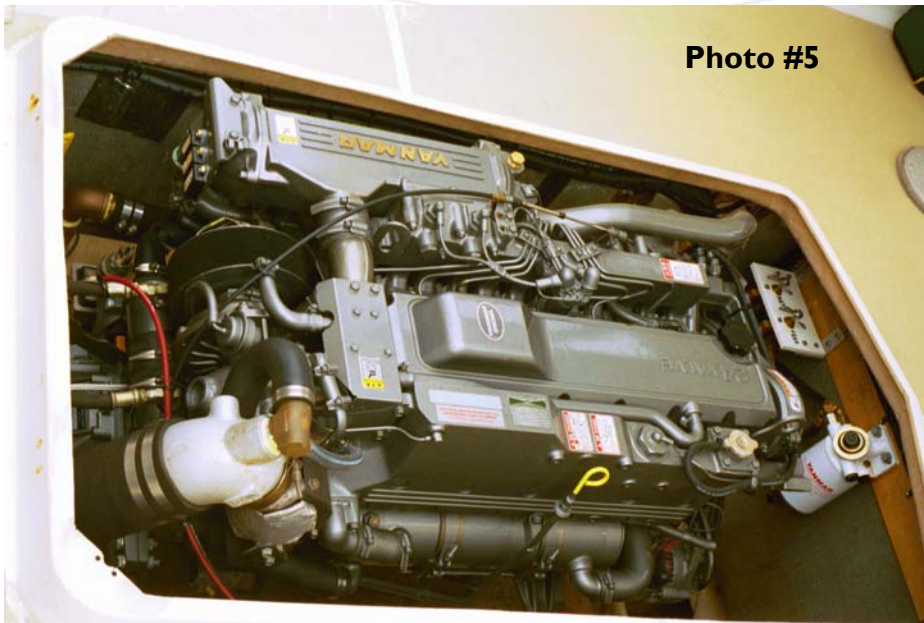
← Engine.

No abnormal conditions were observed with the installation and condition of the engine.

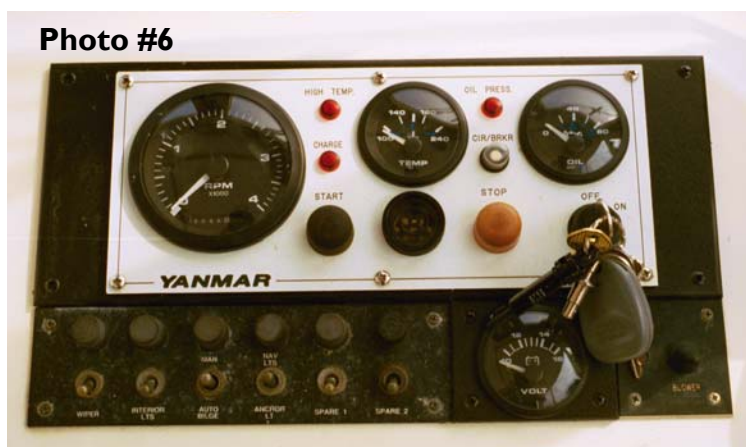
← Helm gauges and DC switches and fuses.

All observed components of the electrical system were normal.

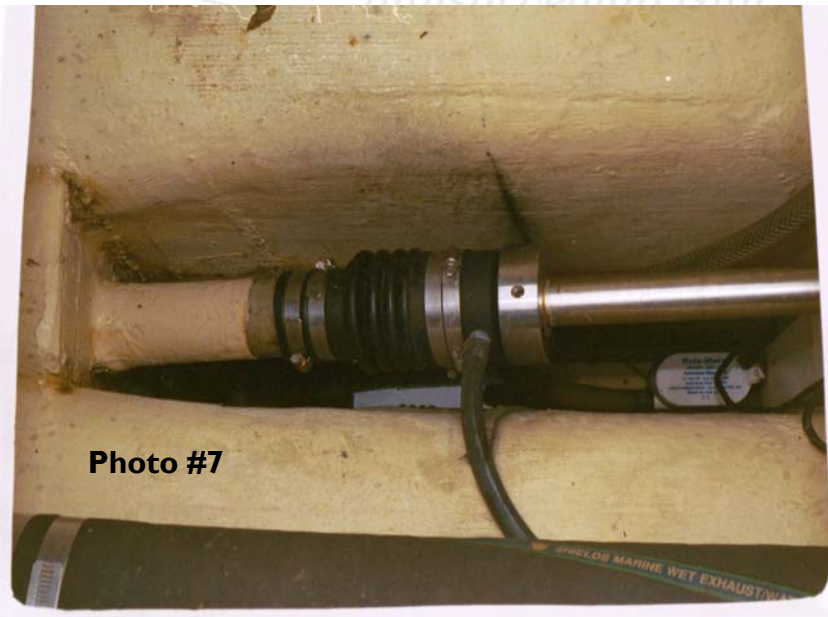
← Bilge pump located in keel sump and dripless shaft packing.

The bilge pump installed on this vessel will provide marginal dewatering capabilities for spray and rain water that finds its way into the bilge. The bilge pumping system will have a difficult time keeping up with any type of flooding.

8	FINDING	RECOMENDATION
	Capacity of bilge pump system is inadequate for a vessel of this size.	Consider adding more bilge pumps, upgrading existing pump capacity, or both. This vessel should carry a minimum of 2 pumps capable of pumping a total of 7000 GPH or more.

9	FINDING	RECOMENDATION
	Vessel is not equipped with a high water bilge alarm.	On vessels with enclosed cabins, consideration should be given to installing an alarm system to indicate that the bilge water is approaching the maximum bilge water level.

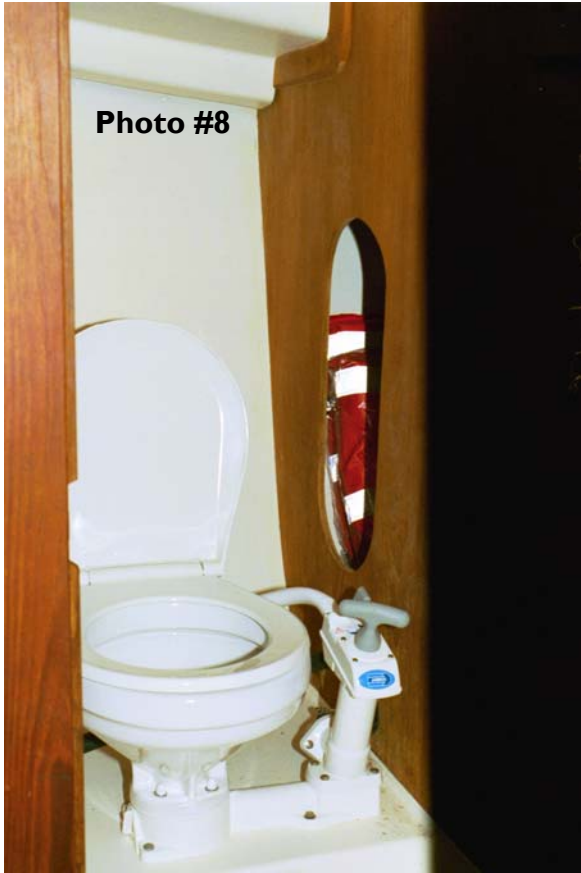
Photo #8

← Head.
